INSPECTION REPORT

**123 Our Street
Hometown, California**

September 9, 2022 - 8:00 A.M.
Report Number 12340922

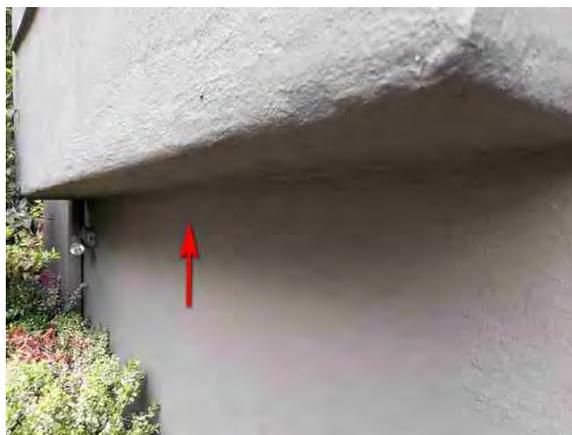
The stucco surfaces below the living room cantilever are not provided with ventilation. Screened ventilation openings are often required in new construction to prevent moisture accumulation and damage to the wooden framing behind the stucco. We recommend the installation of screened vents be considered in the enclosed stucco-sided areas to reduce the potential for moisture accumulation and decay.

Unvented stucco overhang.

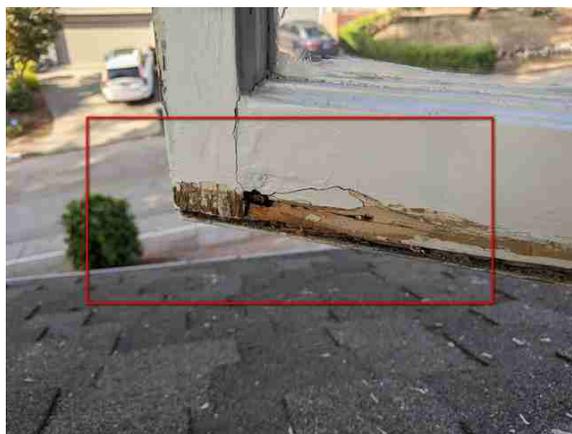
Several window sashes (frames that hold the glass) are damaged. We recommend the damaged sashes be repaired or replaced as needed.

Damaged window sash.

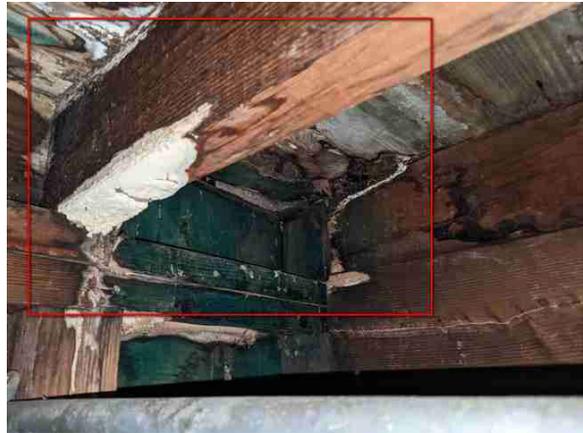
▲ The mortar between the bricks is damaged in several places and has allowed water to penetrate through to the framing. Moisture-related damage was observed under the front porch. We recommend review and repairs as necessary. If a current pest report is not available, we recommend having the property inspected by a licensed structural pest inspector for more information.

Moisture-related damage under front porch.

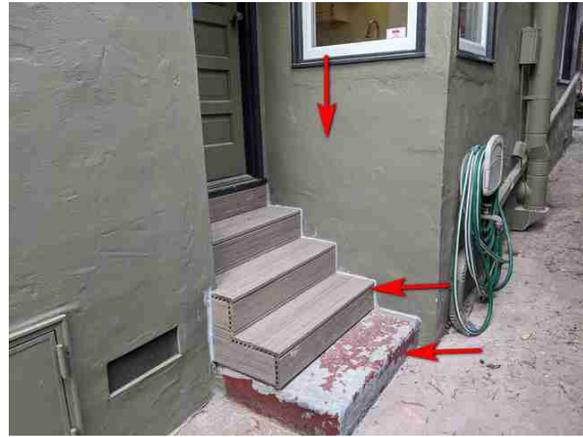
▲ The front and rear entrance steps are uneven, creating potential trip hazards, and we recommend modification as needed to provide a consistent height at each step. Individual steps in staircases should have a consistent height and depth for safe use.

▲ The rear stairs are not provided with proper handrails. We recommend the installation of a handrail in accordance with current standards to reduce the potential for personal injury. Handrails are currently required at stairways with four or more risers.

Uneven steps and missing railing.

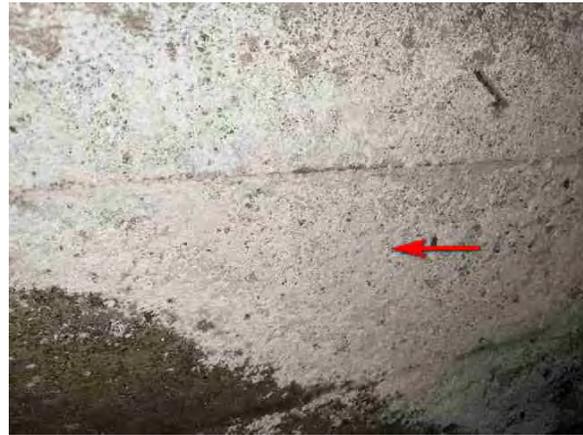
The subfloor area soils were dry at the time of our inspection. We observed efflorescence on the foundation in several places, indicating a surplus moisture condition. Steps should be taken to improve the exterior drainage where appropriate.

Efflorescence.

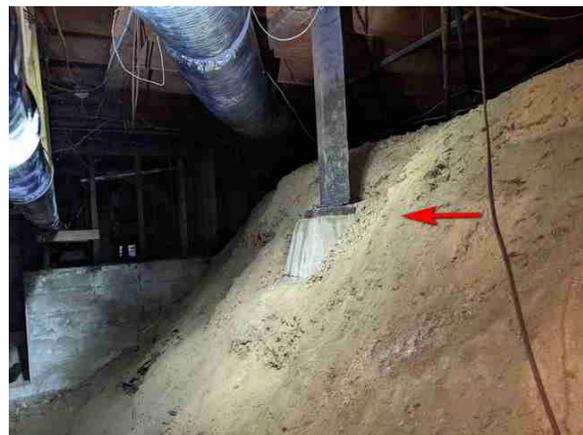
There is an unsupported steep cut in the soil level beneath the building at the left. There is a concrete pier on the soil above the cut-in-grade that may be subject to failure if the soil in this area is not adequately supported. It may be necessary to install concrete retaining walls to support the soil at the change in soil level. Conditions can change over time, and we recommend this area be monitored for soil erosion and corrective action be taken if necessary.

Support pier at steep cut-in grade.
