4-Point Inspection Form

Insured/Applicant Name: Dave Pagano Application / Policy #: _____
Address Inspected: 822 Hamilton Drive, Pleasant Hill, CA 94523
Phone: (925) 222 - 2023 Email: dave@dmpinspections.com
Actual Year Built: 1962 Date Inspected: 10/28/2023

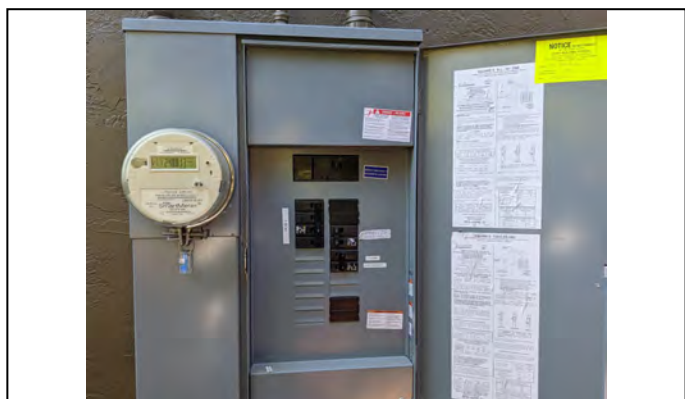
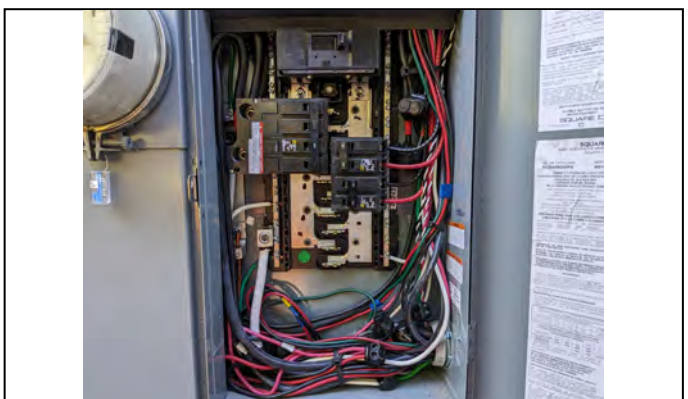
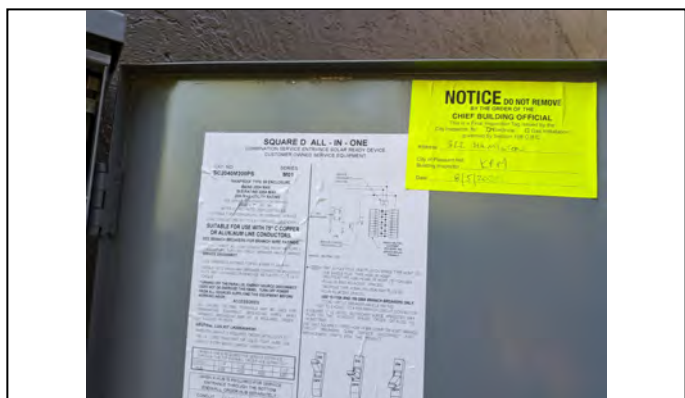
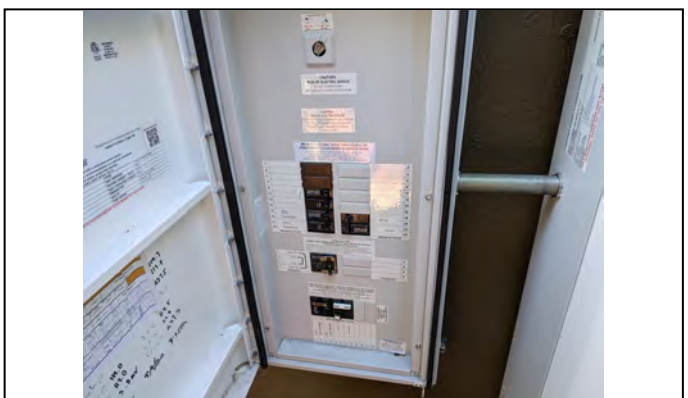
General condition of the electrical system: Satisfactory Unsatisfactory (explain)

Total renovation in 2016

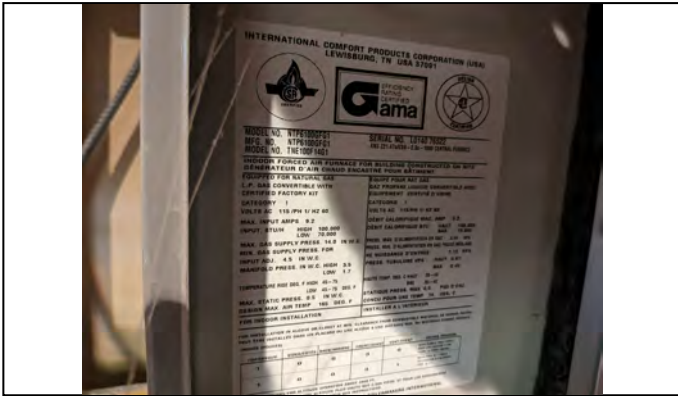
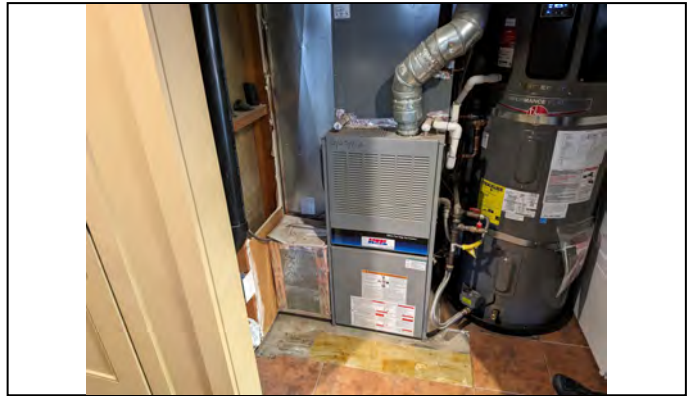
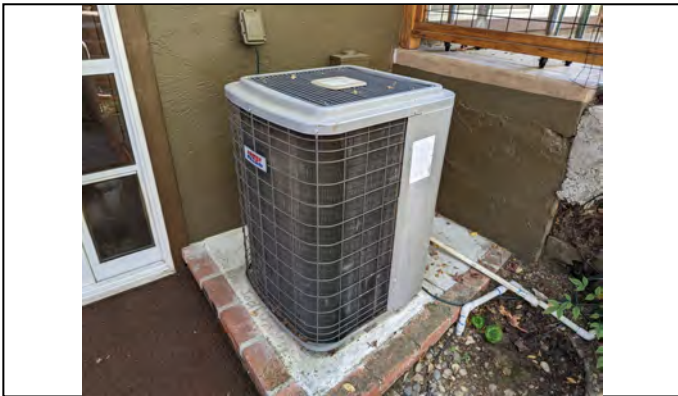
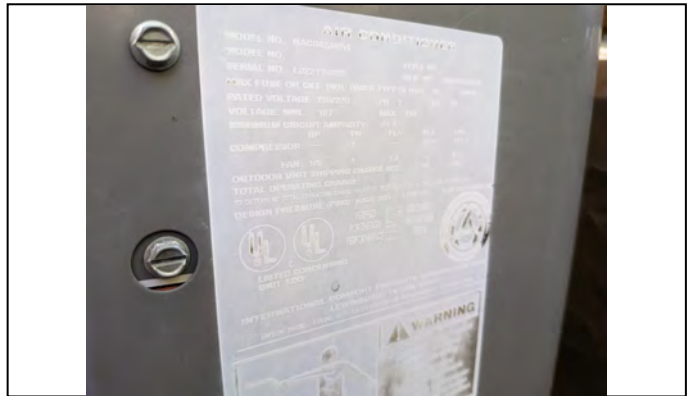
Is this heating, ventilation and air conditioning system in good working order? Yes No (See Additional Comments)

Age of System: 10+ years Year last updated: Unknown

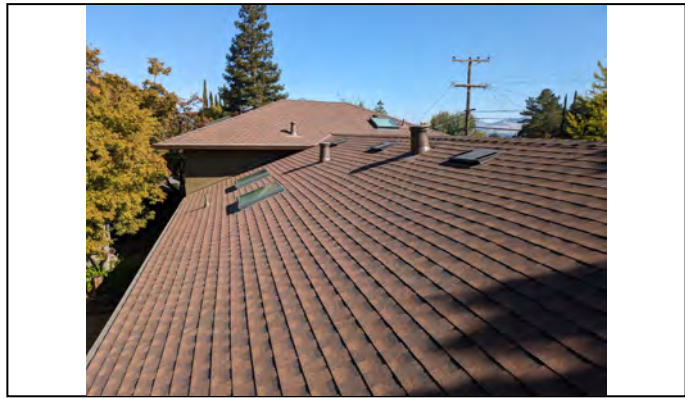
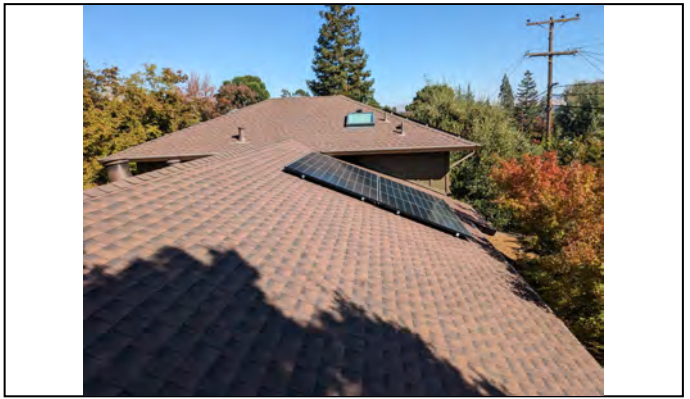
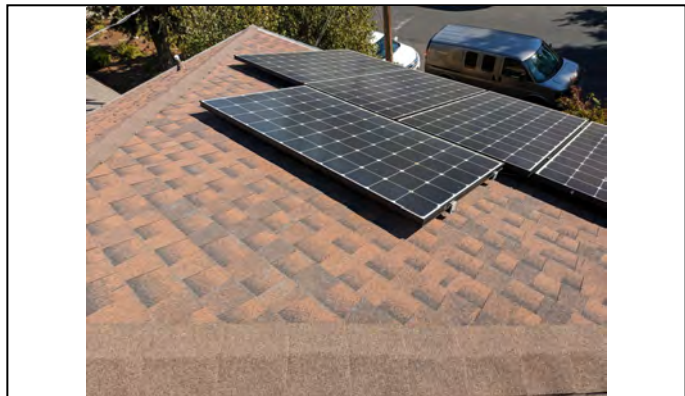
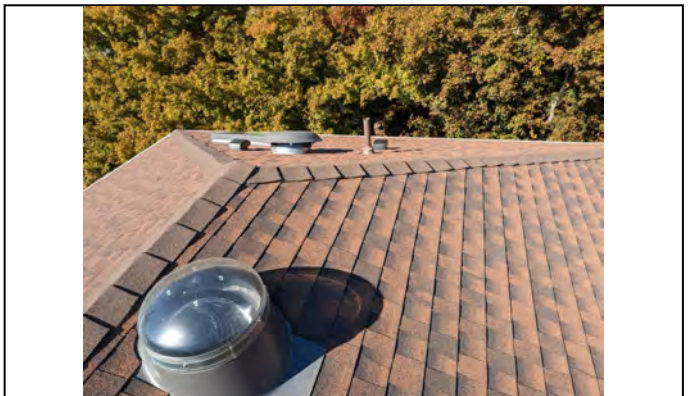
Covering material: Composite Shingle
 Roof age (years): 4 Years
 Remaining useful life (years): Estimate 15+ Years
 Date of last roofing permit: _____
 Date of last update: _____
 If updated (check one):
 Full replacement Partial replacement
 % of replacement: _____
 Overall Condition:
 Satisfactory
 Unsatisfactory (explain below)
