4-Point Inspection Form

DMP INSPECTIONS

Address Inspected: 111 Main Street, Hometown, CA 94523

Actual Year Built: 1956 Date Inspected: 10/05/2023

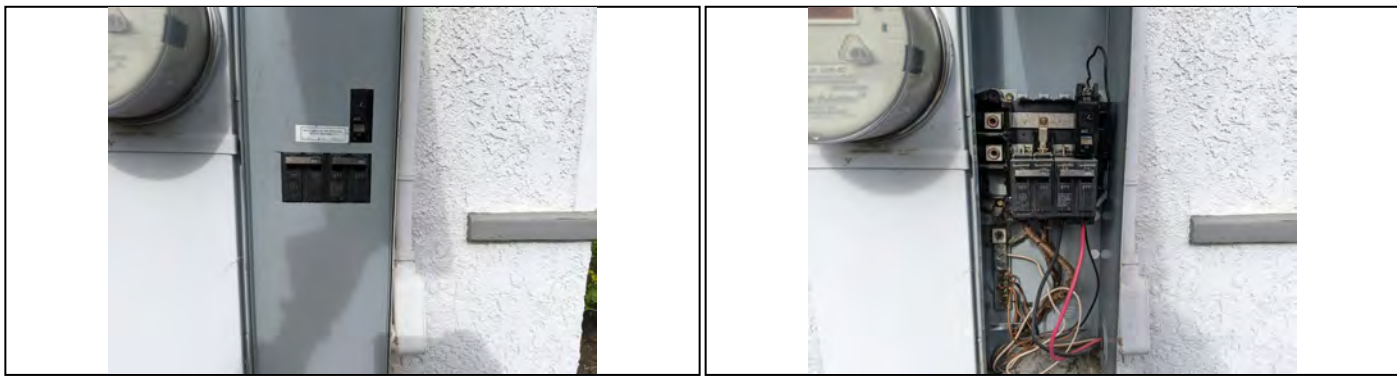
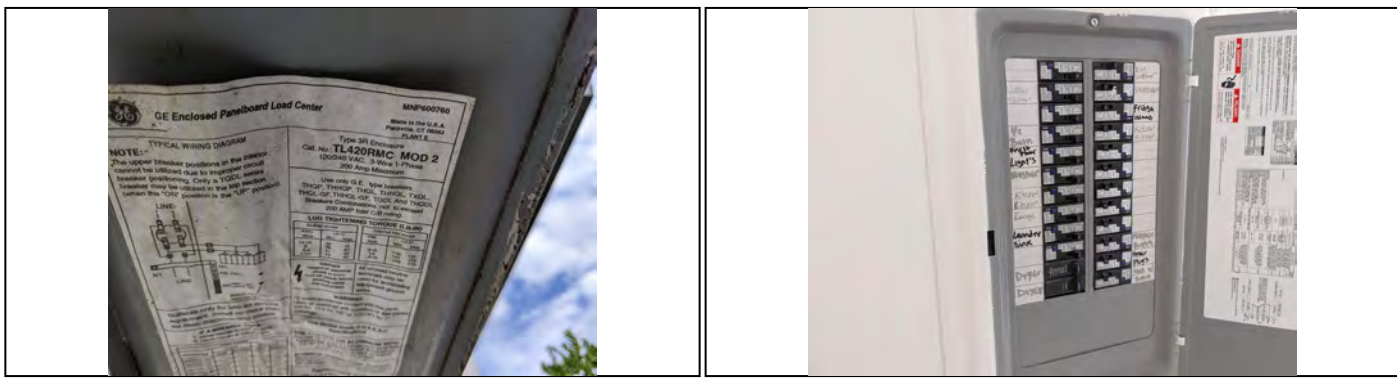
General condition of the electrical system: Satisfactory Unsatisfactory (explain)
 One or more circuit breaker terminals or neutral bar terminals have multiple wires installed. Such "double tapping" can be a hazard because positive connection for all the wires at the terminal is not assured. It is recommended that electrical work be completed by a licensed electrician.

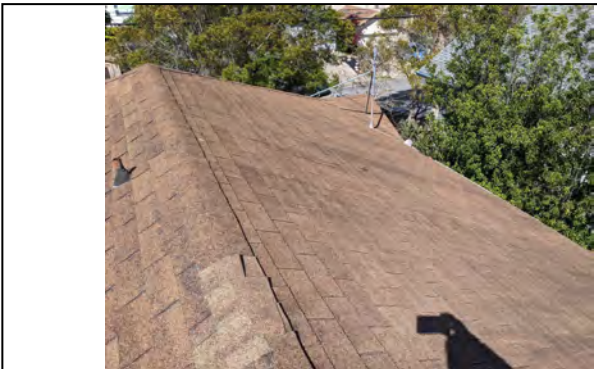
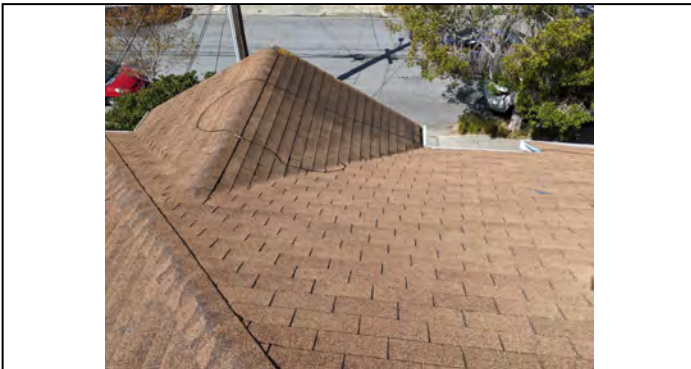
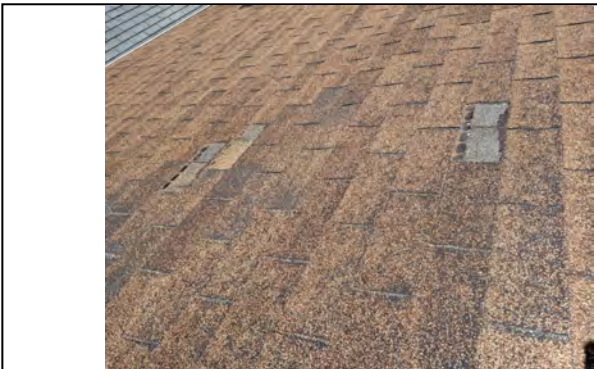
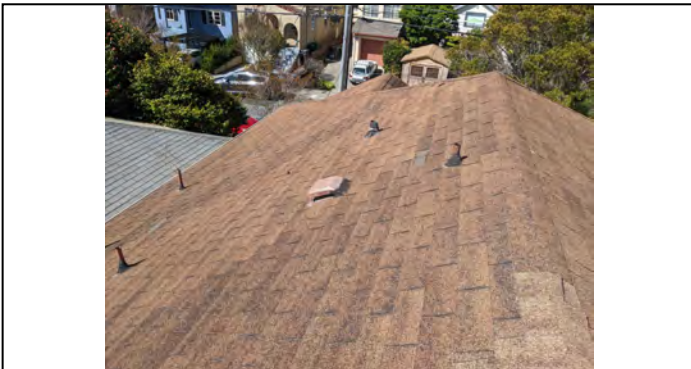
Covering material: Composite Shingle
 Roof age (years): 15+ Years
 Remaining useful life (years): Estimate <1 Year
 Date of last roofing permit: _____
 Date of last update: _____
 If updated (check one):
 Full replacement Partial replacement
 % of replacement: _____
 Overall Condition:
 Satisfactory
 Unsatisfactory (explain below)
