4-Point Inspection Form

DMP INSPECTIONS

Address Inspected: 111 Main Street, Hometown, CA 94523

Actual Year Built: 1956 Date Inspected: 10/05/2023

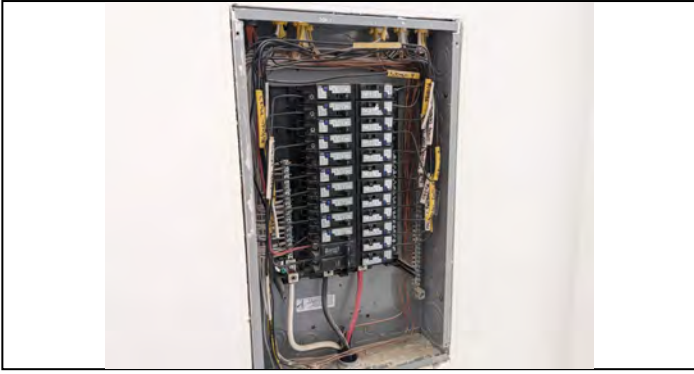
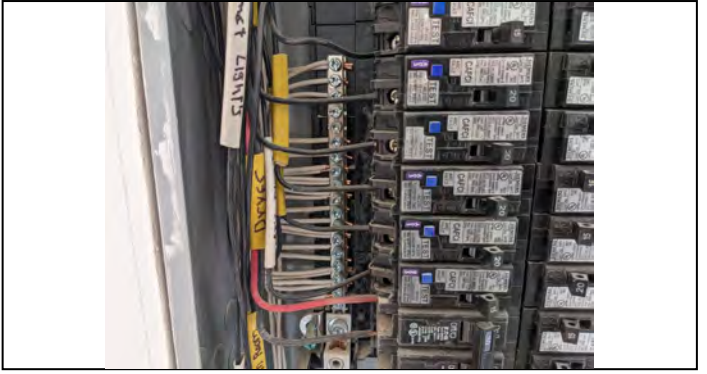
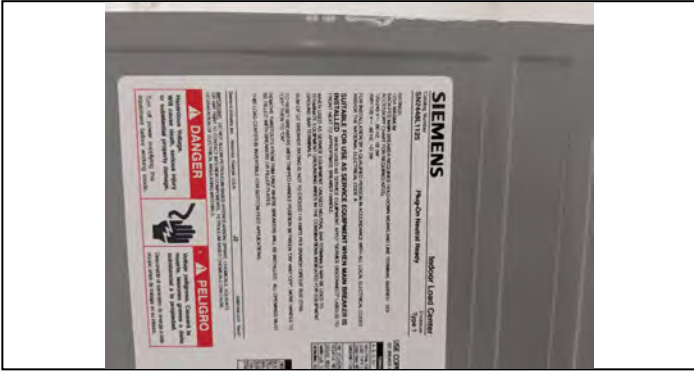
General condition of the electrical system: Satisfactory Unsatisfactory (explain)
 One or more circuit breaker terminals or neutral bar terminals have multiple wires installed. Such "double tapping" can be a hazard because positive connection for all the wires at the terminal is not assured. It is recommended that electrical work be completed by a licensed electrician.

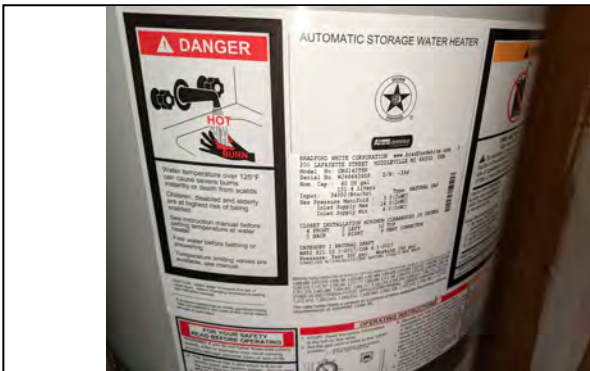
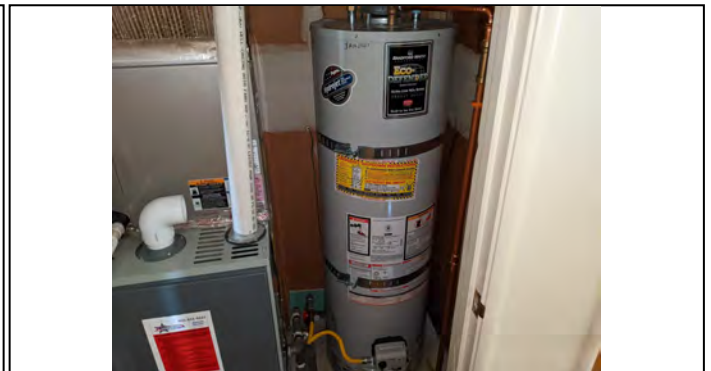
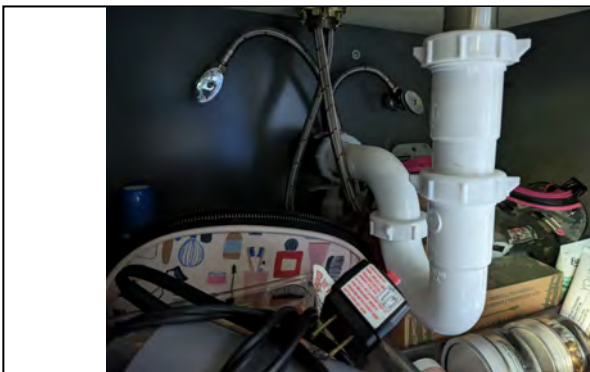
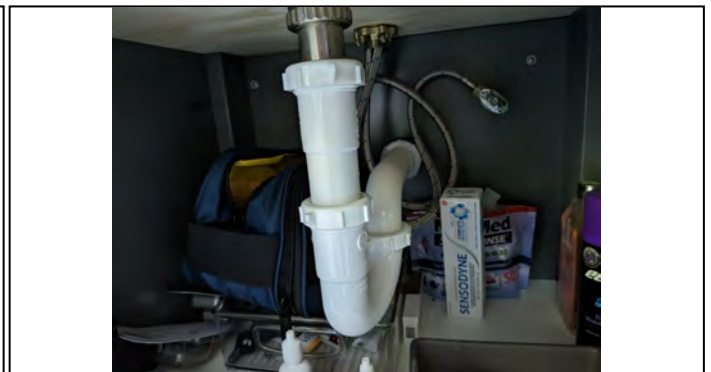
Is there a temperature pressure relief valve on the water heater? Yes No
 Is there any indication of an active leak? Yes No
 Is there any indication of a prior leak? Yes No
 Water heater location: Closet

Some shut-off valves, riser lines and plumbing fixtures replaced with routine maintenance and updates.
